BEAVER LAKE LODGE DAM

NDI I.D. NO. PA-00300
PENNDER I.D. NO. 52-93

PHASE I INSPECTION REPORT
NATIONAL DAM INSPECTION PROGRAM

JUNE 1981

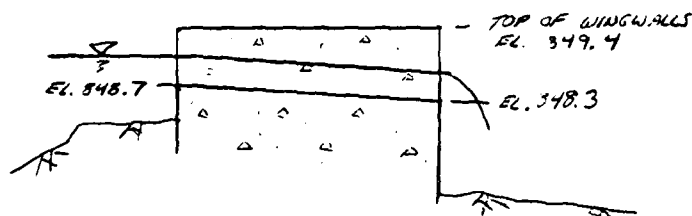
2.) EMERGENCY SPILLWAY

EFFECTIVE CREST LENGTH = 38 FT
